AEFA PROJECT NO. 86-10

US ARMY AVIATION SYSTEMS COMMAND

PRELIMINARY AIRWORTHINESS EVALUATION OF THE UH-60A EQUIPPED WITH THE XM-139 VOLCANO MINE DISPENSING SYSTEM

FINAL REPORT

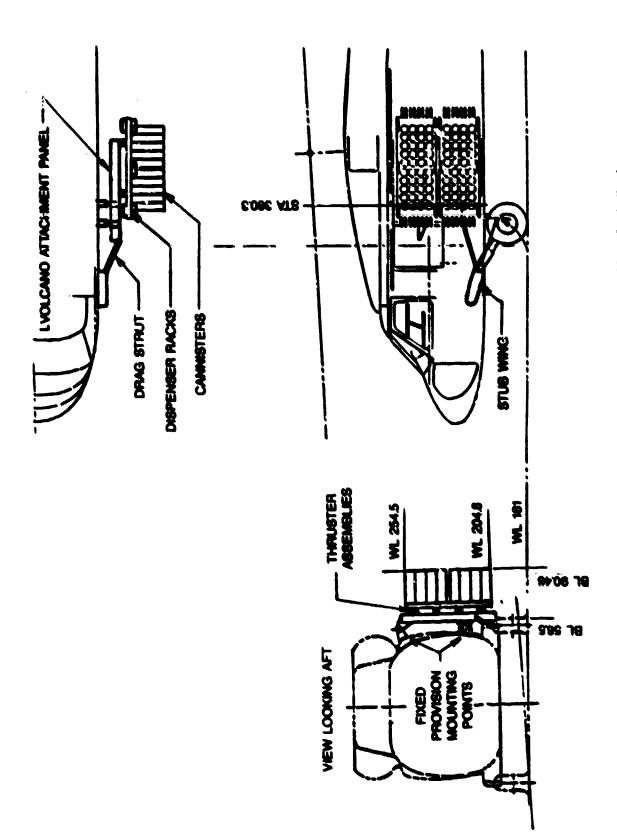
Figure 1. MF-139 VOLCANO Hime Dispenser System, UB-60A Black Hank

2. The XM-139 VOLGANO weapons system with related equipment is produced by Honeywell, Inc. The VOLGANO is an automated, scatterable mine delivery system capable of launching mines from host ground and air vehicles (5 ton dump and cargo trucks and the UH-60A helicopter). The mine dispenser system is modular and consists of four major components: (1) mounting hardware kits, (2) four launcher racks, (3) 160 mine canisters, and (4) a Dispenser Control Unit (DCU). Dimensions and weights of these components are summarized in table 1 and aircraft mounting locations are shown in figure 1.

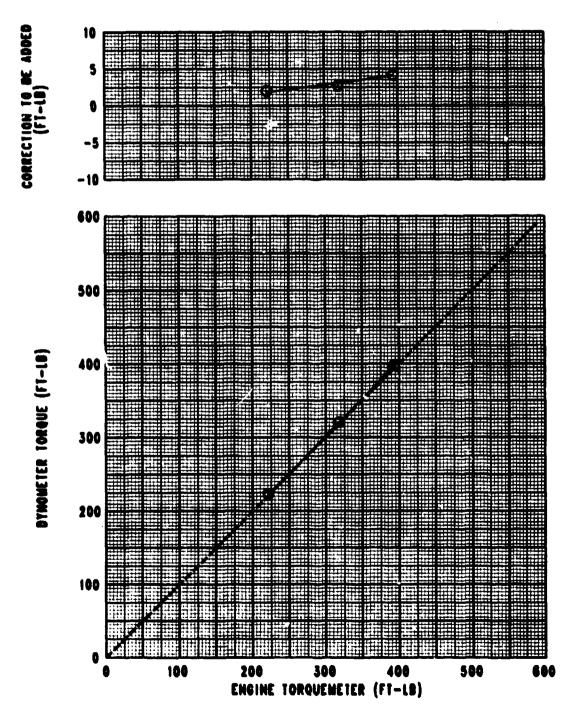
FIGURE 3 ENGINE TORQUEMETER CALIBRATION UH-60A USA S/N 84-23953 1700-GE-700 S/N 306625

NOTES: 1. NUMBER ONE ENGINE

- 2. POWER TURBINE SPEED = 20,900 RPM
- 3. DATA OBTAINED FROM G E ENGINE PRODUCTION RATING SHEET

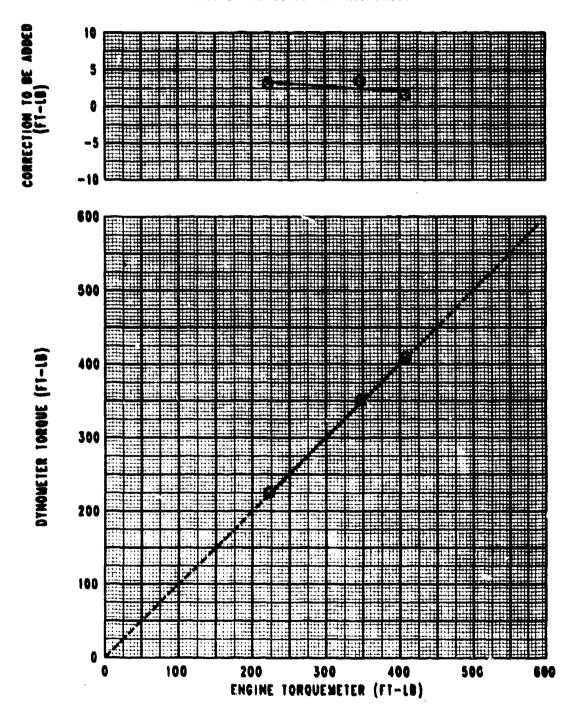
FIGURE 4 ENGINE TORQUEMETER CALIBRATION UH-60A USA S/N 84-23953 1700-GE-700 S/N 306629

NOTES: 1. NUMBER TWO ENGINE

- 2. POWER TURBINE SPEED = 20,900 RPM
- 3. DATA OBTAINED FROM G E. ENGINE PRODUCTION RATING SHEET

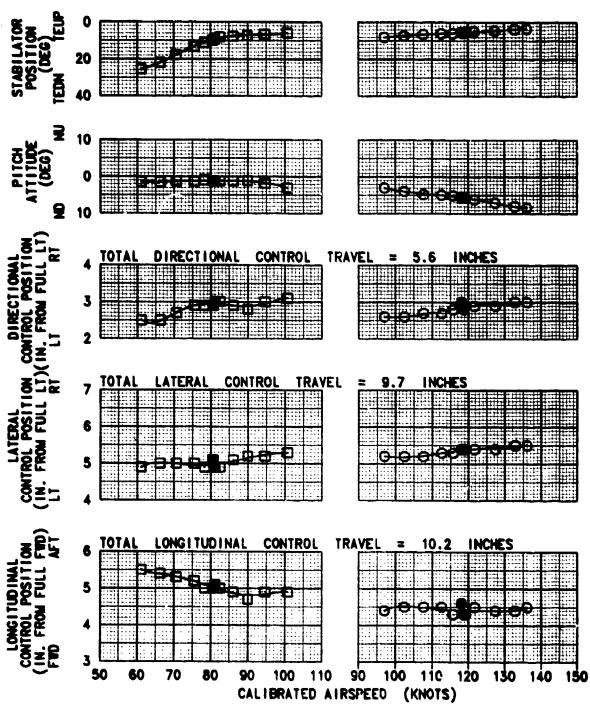
FIGURE 16 COLLECTIVE-FIXED STATIC LONGITUDINAL STABILITY UH-60A USA S/N 84-23953

VOLCANO CONFIGURATION LEVEL FLIGHT SHADED SYMBOLS DENOTE TRIM POINTS BALL-CENTERED FLIGHT PBA CENTERED AND LOCKED

10. The static longitudinal straility characteristics were evaluated at the conditions presented in table 2. The helicopter was stabilized in ball-centered flight at the desired trim airspeed and flight condition. The collective control was held fixed while airspeed was varied incrementally approximately +20 knots about trim. Test results are shown in figures 16 through 18. The static longitudinal stability, as indicated by the variation of longitudinal cyclic control position with airspeed, was positive (0.025 in/kt) (forward longitudinal cyclic control position to maintain increased airspeed) at 81 KCAS, but neutral at maximum airspeed in level flight at intermediate rated power (IRP) VH (118 KCAS). Control force cues of longitudinal cyclic control displacement about trim were weak, but sufficient for airspeed control within + 2 knots during normal mission maneuvering. The static longitudinal stability characteristics were essentially the same during climbs, descents, and level flight and were similar to the normal utility UH-60A. The static longitudinal stability characteristics are satisfactory, but did not meet the requirements of MIL-H-8501A in that the static longitudinal stability was neutral at Vy.

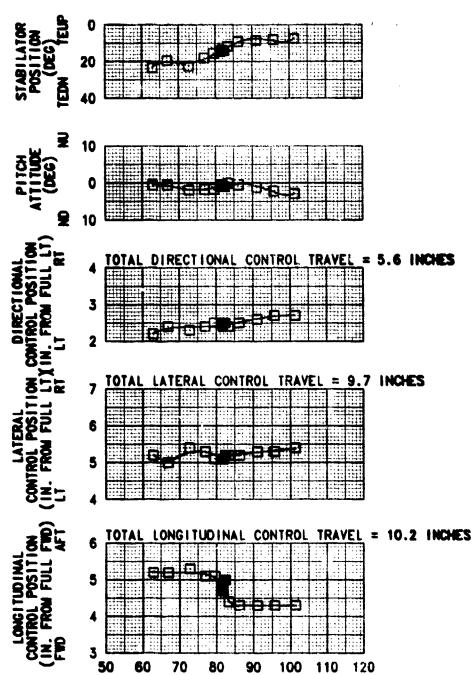
FIGURE 17 COLLECTIVE-FIXED STATIC LONGITUDINAL STABILITY UH-60A USA S/N 84-23953

AVG GROSS	CG LOCA		AVG DENSITY	AYG OAT	AVG ROTOR	TRIM CALIBRATED AIRSPEED
MEIGHT	LONG (FS)	(BL)	(FT)	(DEG C)	SPEED (RPM)	AIRSPEED (KTS)
20700	351.4MID	0.3 LT	5140	15.0	258	82

- NOTE:
- VOLCANO CONFIGURATION IRP CLIMB SHADED SYMBOLS DENOTE TRIM POINT BALL-CENTERED FLIGHT PBA CENTERED AND LOCKED

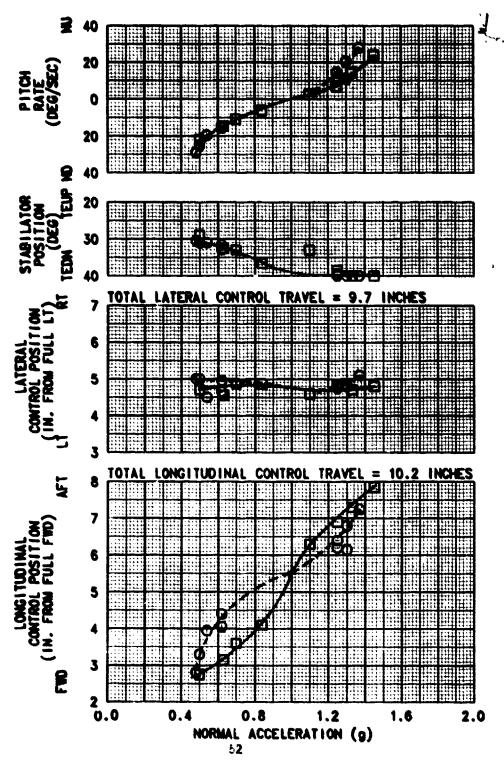
FIGURE 23 MANEUVERING STABILITY SYMMETRICAL PUSHOVERS AND PULLUPS UH-GOA USA S/N 84-23953

AVE AVE AVE AVE AVE AVE AVE TRIM SAS GROSS CG LOCATION DENSITY OAT ROTOR CALIBRATED CONDITION WEIGHT LONG LAT ALTITUDE SPEED AIRSPEED SYMBOL (LB) (FS) (BL) (FT) (DEG C) (RPM) (KTS)

20980 351.0MID 0.3 LT 4950 13.5 259 100 CM
C 20780 350.3MID 0.3 LT 5000 14.5 259 100 CFF

NOTE: 1. VOLCANO CONFIGURATION
2. PBA CENTERED AND LOCKED

- 12. Maneuvering stability was evaluated at the conditions presented in table 2 in left and right collective-fixed, steady-state turns, symmetrical pull-ups and pushovers. The steady-state turn tests were accomplished by initially stabilizing the helicopter in ball-centered level flight at the trim airspeed and then incrementally increasing the normal acceleration (g) by increasing the bank angle in left and right turns. Constant collective control position was maintained during the maneuvers and the pilot attempted to maintain a constant airspeed. Symmetrical pull-ups and pushovers were conducted by alternately climbing and diving the helicopter to achieve varying g while the aircraft was passing through the trim altitude at the desired airspeed. Test results are presented in figures 22 through 25.

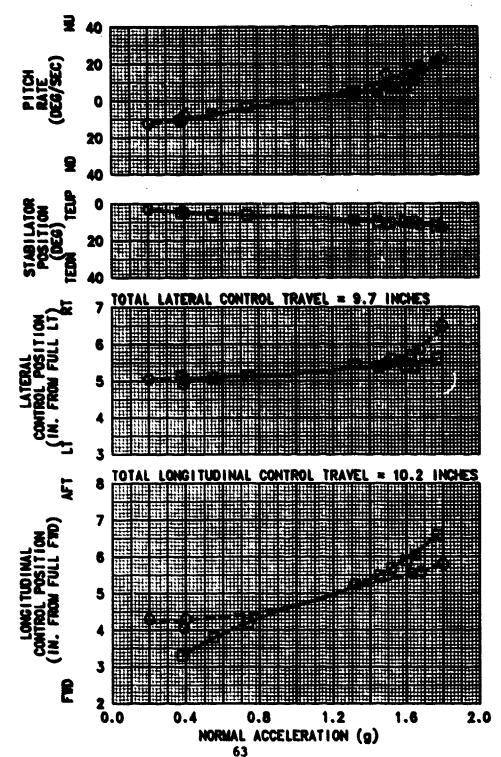
FIGURE 24 MANEUVERING STABILITY UH-60A USA S/N 84-23953

GROSS	CG LOCA	ATION	AVG DENSITY	AVG	AVG ROTOR	TRIM	TRIM FLIGHT	SAS CONDITION
SYM	WEIGHT (LB)	LONG (FS)	LAT (BL)	ALTITUDE. (FT)	(DEG C)	SPEED (RPM)	AIRSPEED (KTS)	CONDITION	
⊡	20970	350.9MID	0.3 LT	765Ó	11.5	`258´	`40 ′	RIGHT TURN	ON
Ō	20940 20900	350.8MID 350.7MID	0.3 LT 0.3 LT	7060 6650	11.5	258 258	42 40	LEFT TURN RIGHT TURN	OFF
$\overline{\diamond}$	20850	350.5MID	0.3 LT	6400	12.0	258	41	LEFT TURN	OFF

VOLCANO CONFIGURATION SHADED SYMBOLS DENOTE TRIM POINT PBA CENTERED AND LOCKED

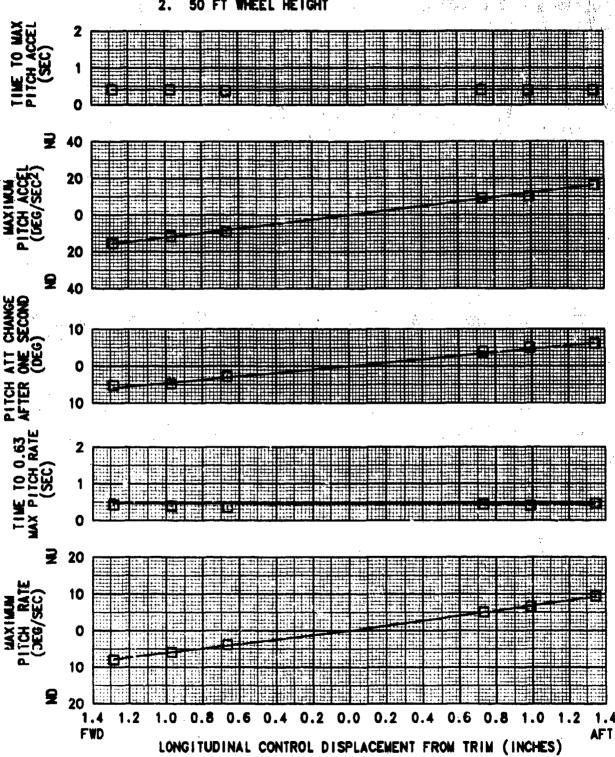
FIGURE 40 LONGITUDINAL CONTROLLABILITY UH-60A USA S/N 84-23953

AVG AVG AVG AVG AVG TRIM GROSS CG LOCATION DENSITY OAT ROTOR CALIBRATED WEIGHT LONG LAT ALTITUDE SPEED AIRSPEED (LB) (FS) (BL) (FT) (DEG C) (RPM) (KTS) 20580 351.8MID 0.3 LT -180 15.0 259 000

NOTE: 1. XM-139 VOLCANO SYSTEM INSTALLED (FULL CANISTERS)
2. 50 FT WHEEL HEIGHT

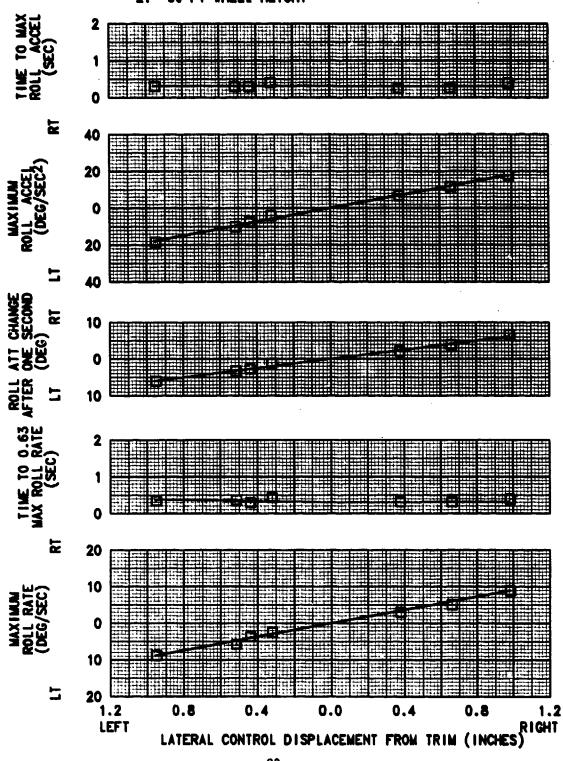
FIGURE 43
LATERAL CONTROLLABILITY
UH-60A USA S/N 84-23953

AVG DENSITY AYG OAT AVG ROTOR AYG AVG TRIM CG LOCATION LONG LA (FS) (B GROSS WEIGHT AIRSPEED (KTS) (RPM) (DEG C) (BL) (FT) 20390 350.5MID 0.3 LT 000 -150 15.5 259

NOTE: 1. XN-139 VOLCANO SYSTEM INSTALLED (FULL CANISTERS)
2. 50 FT WHEEL HEIGHT

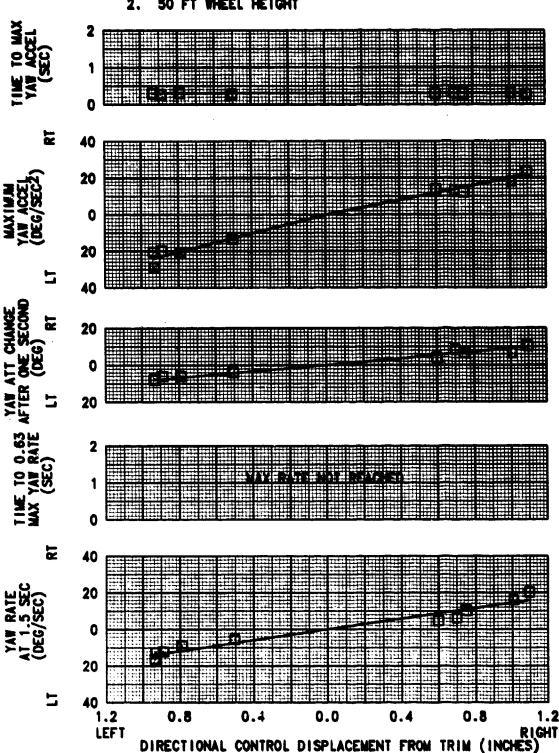
FIGURE 46
DIRECTIONAL CONTROLLABILITY
UH-60A USA S/N 84-23953

AVG AVG AVG AVG AVG TRIM
GROSS CG LOCATION DENSITY OAT ROTOR CALISRATED
WEIGHT LONG LAT ALTITUDE SPEED AIRSPEED
(LB) (FS) (BL) (FT) (DEG C) (RPM) (KTS)
20100 349.0MID 0.3 LT -140 15.5 259 000

NOTE: 1. XM-139 VOLCANO SYSTEM INSTALLED (FULL CANISTERS)
2. 50 FT WHEEL HEIGHT

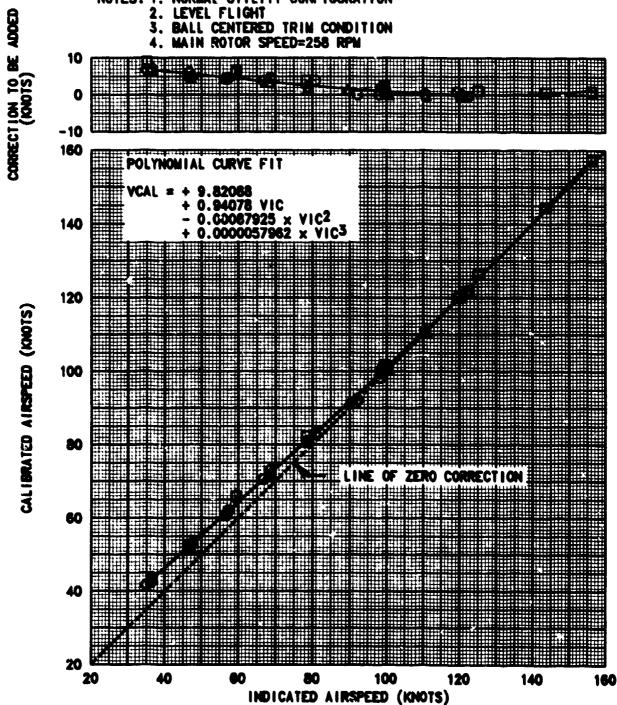
FIGURE 55
SHIP AIRSPEED CALIBRATION
UH-60A USA S/N 84-23953

SYM	AVG GROSS WEIGHT (LB)	C.G. LOG LONG (FS)	G CATION LAT (BL)	AVG DENSITY ALTITUDE (FEET)	AYG OUTSIDE AIR TEMP. (DEG C)	TEST METHOD
⊙ △	15270	350.6	0.2	3350	13.5	TRAILING BOMB
	18600	350.6	0.2	6200	17.5	TRAILING BOMB
	17500	350.0	0.2	-10	16.0	GRND SPD CRSE

4. The test boom airspeed system along with the ship's standard systems were calibrated in level flight using a calibrated trailing bomb to determine the position error. Sikorsky's ground speed course was used to determine the high speed calibration data (above 120 knots indicated airspeed). The position error of the boom airspeed system is presented in figures 1 through 2.

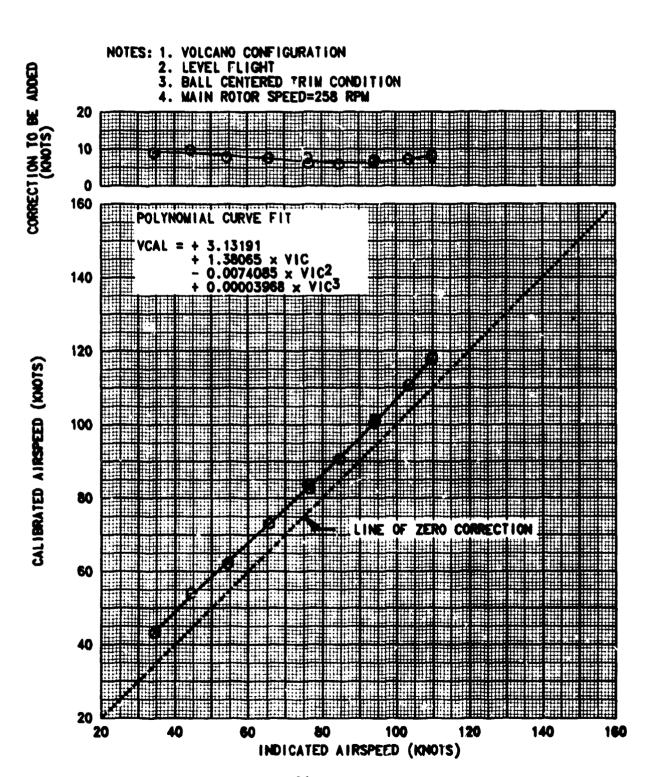
FIGURE 56 SHIP AIRSPEED CALIBRATION UH-60A USA S/N 84-23953

AVG GROSS WEIGHT (LB)	C.G. LO Long (FS)	G CATION LAT (BL)	AVG DENSITY ALTITUDE (FEET)	AVG OUTSIDE AIR TEMP. (DEG C)	TEST METHOD
20570	350.8	0.2	5200	6.5	TRAILING BOMB
